National Sports Council
Dasarath Rangasala

Research Report on
Seismic Vulnerability Assessment
of
Dasarath Rangasala

July 2013

Center of Resilient Development (CoRD)

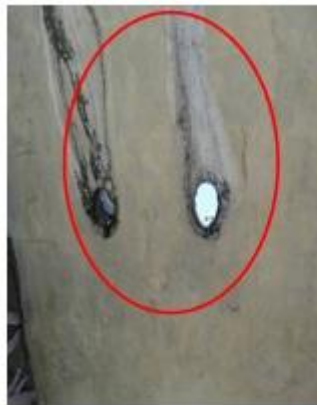
Photo=VIP1: Seepage Problem

The seepage problem is found to be significant at most of the locations especially at the joints. The joints are not properly sealed as a result of which the water from the top seating area is getting drained straight into the walls and slabs. This affects structure adversely and in result affects the quality of the concrete and is causing corrosion on steel bars. The block D where there are restroom facilities for the officials and the athletes is found to bear the same problem.

The seepage has caused spalling of the concrete and carbonation of the existing rebars significantly and is spreading rapidly. The rebar have been exposed at few locations and corrosion has been observed on it. There is an urgent need to improve the drainage facility by sealing the concrete surface against any water seepage.

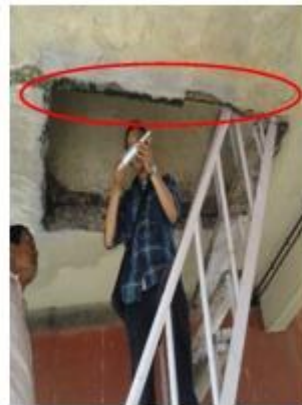
Photo=VIP 2: Concrete Spalling, Rebar Corrosion

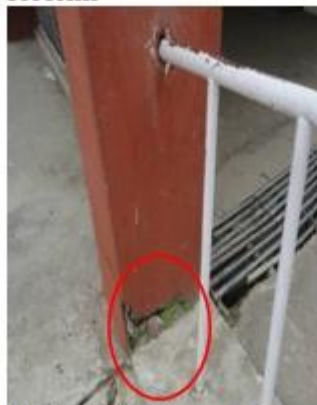
Photo=VIP4; Concrete spalling/ cracks seen

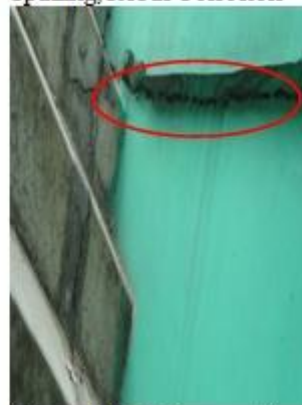
Photo=G1: Wall separation under beam

and plasters to crack. There is an urgent need of repair and maintenance work to correct the defects on walls and joints.

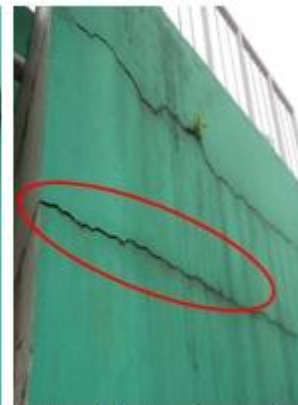
Photo= G2: Cracks seen in the walls.

Most of the walls are free from cracks and found in good condition during physical inspection. The cracks are observed at the corners where two walls meet and also at the slab-wall junction. Damp patches are found in the walls resulting in the spalling of the concrete

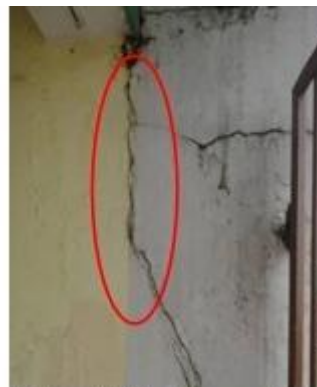
Photo=G3; Cracks seen at beam-column interface

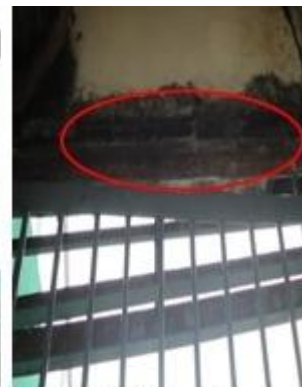
Photo=F4; Concrete spalling/ Rebars Exposed

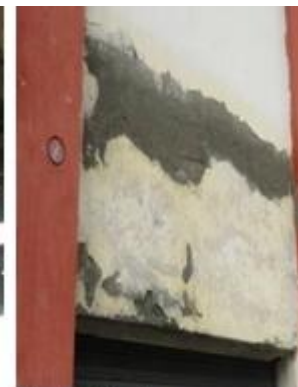
Photo=D1: Seepage Problem

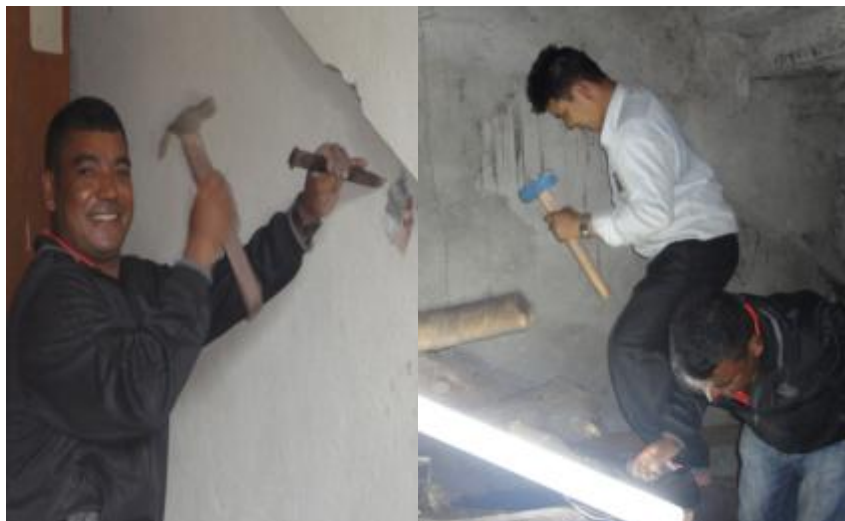
Since the building's structure in a normal condition is concealed by the architectural finishes, so necessary surface preparation works i.e. removal of those finishes were required before the testing at the pre-identified locations.

Figure 5-1 Surface preparation works

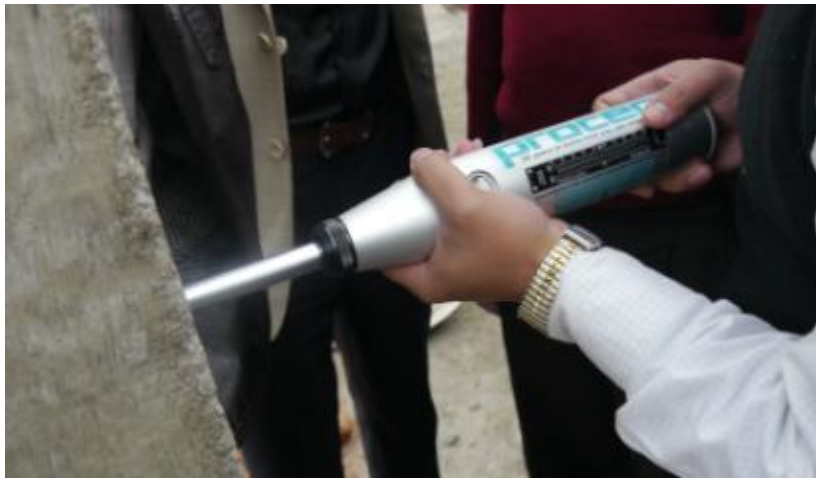
The most common method to determine the compressive strength of concrete without destructing it is by using Schmidt hammer. The Schmidt hammer test enables us to determine the in-situ compressive strength of the concrete and assess the current strength of the concrete as it stands today.

The test was conducted on columns, beams and slab of each block – Block B, C, D, E and VIP block. The results showed that the surface of the concrete has hardened due to carbonation of concrete surface and hence obtained value is quite higher i.e., 30MPa though the estimated compressive strength of the concrete should not be more than 20 MPa.

Figure 5-2 Schmidt Hammer

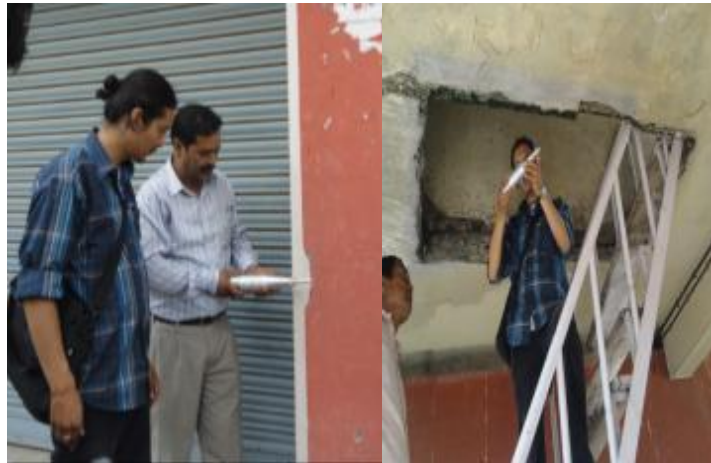
Figure 5-3 Carrying out Schmidt hammer test

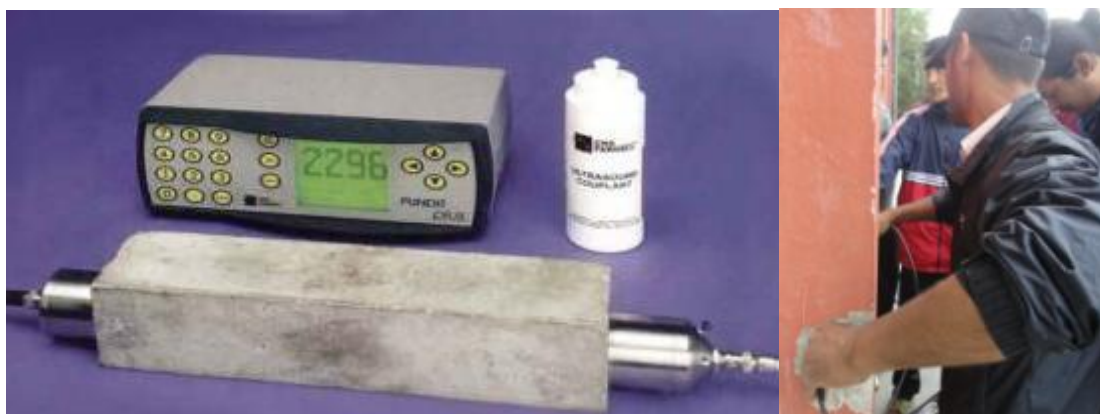
Figure 5-4 performing Ultra sonic pulse velocity

This test was performed on the columns and slabs of each block- block B, C, D, E, VIP block. The test showed that the average velocity in the concrete columns is 2918.72 m/s i.e. 2.92 Km/s which falls in the poor category of Table 5-1.

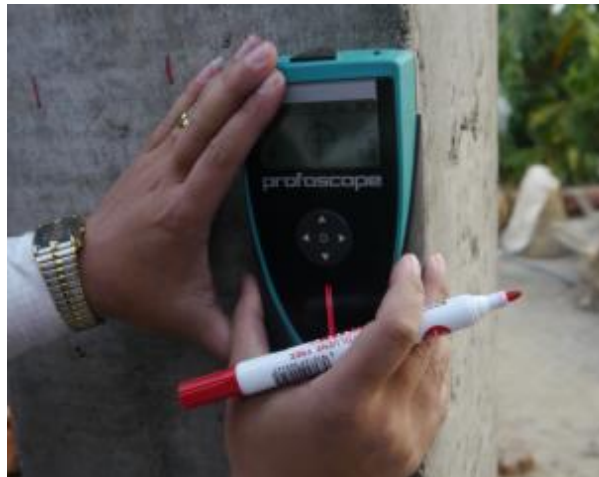
The test detected only 8 numbers of rebar in the columns of block B, C, D and E which is lower than the required reinforcement.

Figure 5-5 Cover meter and rebar detector test
